NASA CR-165297 PWA-5512-75

PERFORMANCE DETERIORATION
BASED ON SIMULATED AERODYNAMIC LOADS TEST

J.9D JET ENGINE DIAGNOSTICS PROGRAM

UNITED TECHNOLOGIES CORPORATION Pratt & Whitney Aircraft Group Commercial Products Division

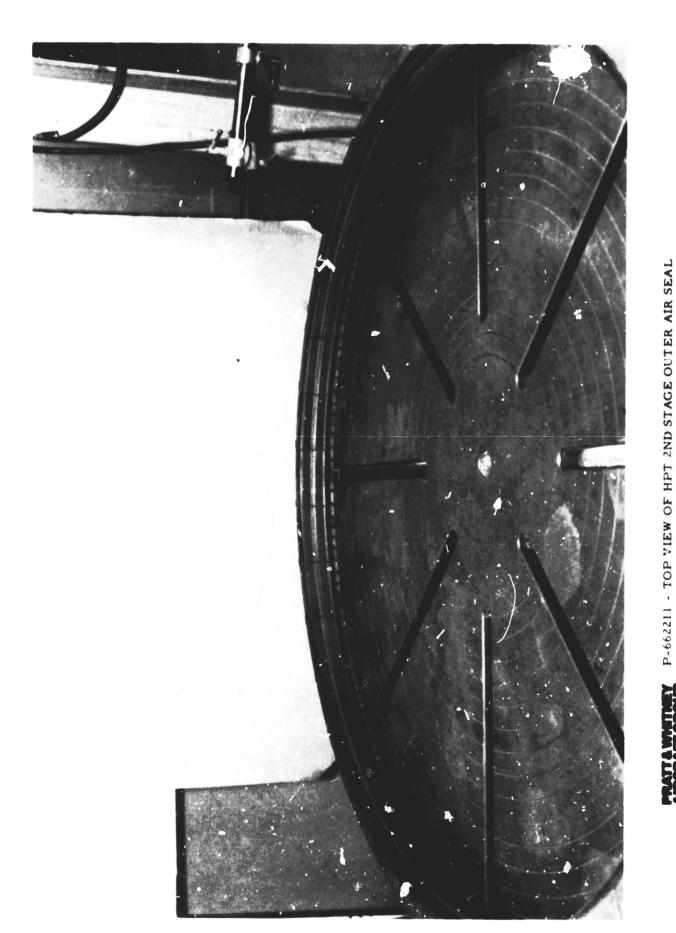
P:662211 - BOTTOM VIEW OF HPT 2ND STAGE OUTER AIR SEAL

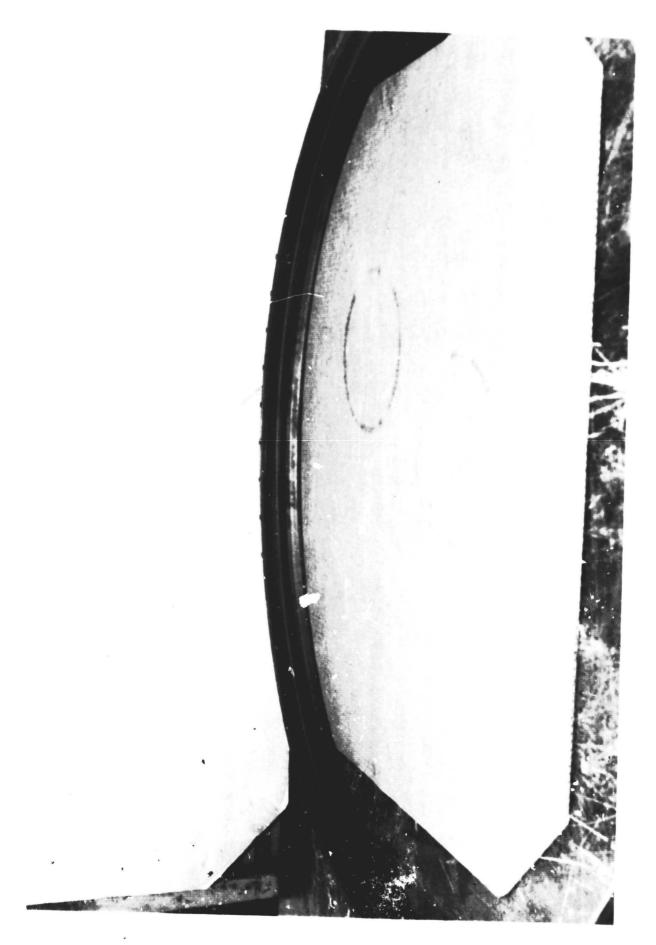
P-662211 - BOTTOM VIEW OF LPT 4TH STAGE OUTER AIR SEAL
